Town of Qualicum Beach
M E M O R A N D U M

SUBJECT: Elizabeth Little Waterfront Park – Tree Assessment and Replanting Plan

Tree Management Recommendations

Former St. Andrews Lodge

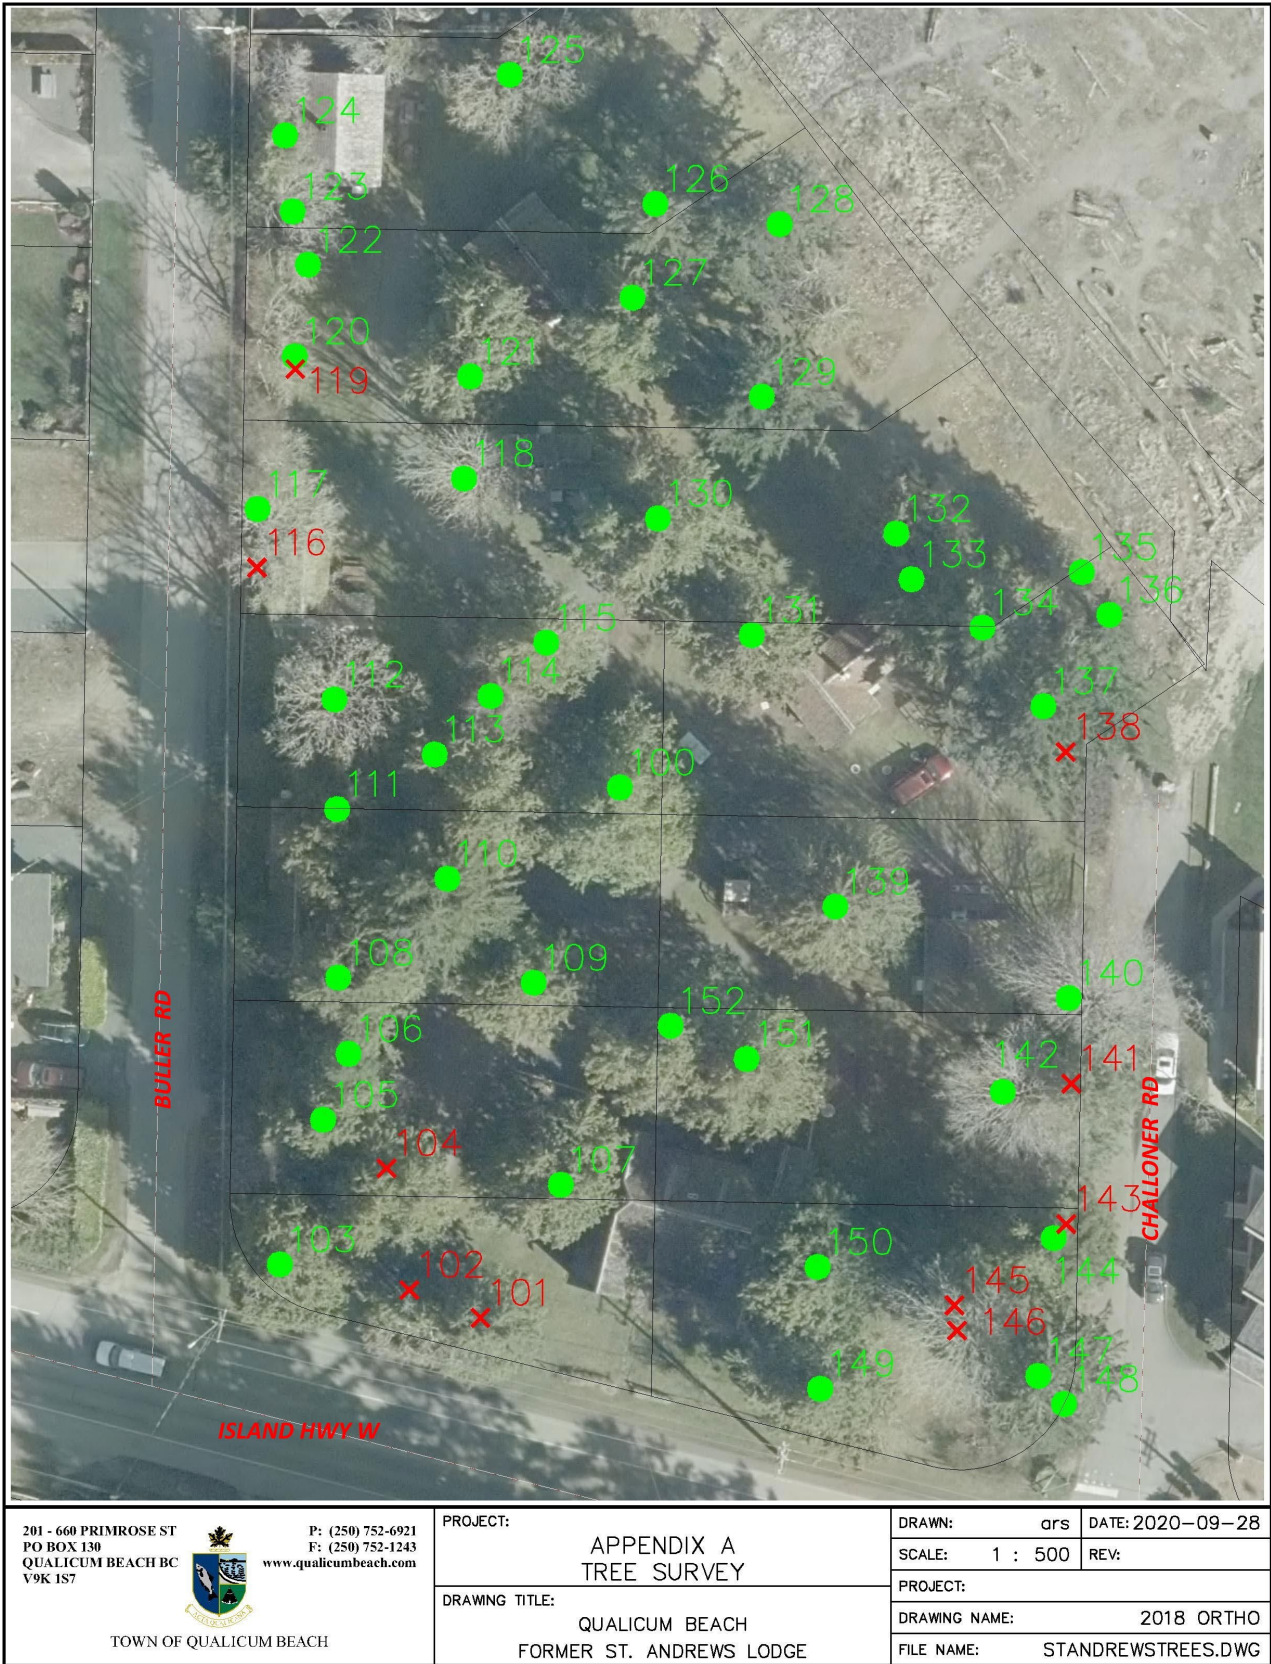
Appendix A – Tree Survey

There were 53 trees inspected by the Viking Tree Care. They are numbered and tagged in the field and a report was submitted for all the numbered trees. The original report contains evaluations of 53 trees, all of which are shown on the map in "Appendix A – Tree Survey", and 30 of the 53 trees required further canopy inspection to evaluate their health. Most of the trees that were inspected have been altered and topped at some point in the past and those practices have created less than ideal conditions for the health of the trees. The remaining trees on the property that are 30cm diameter at breast height (DBH) and smaller were inspected by the Town of Qualicum Beach arborist and recommendations are provided in this report.
